THE UNIVERSITY OF NEW SOUTH WALES SCHOOL OF MECHANICAL AND INDUSTRIAL ENGINEERING.

RESTORATION OF THE STEAM TUG 'WARATAH'.

BACHELOR OF ENGINEERING

(NAVAL ARCHITECTURE).

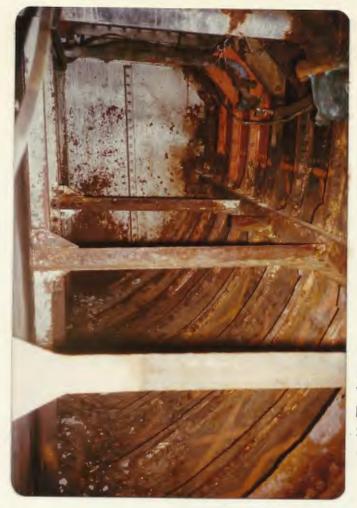
PLATE XIII. (left)
PORT WING BUNKER PRIOR TO
RESTORATION WITH CEILING
REMOVED SHOWING CORROSION
OF HULL BENEATH. (Author, 1977)

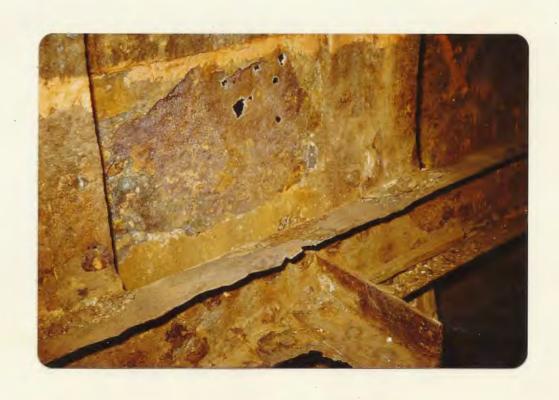
PLATE XIX. (below)
HEAVY CORROSION IN PORT
WING BUNKER SHOWING HOLES
IN SHELL AND WASTED
STRUCTURE PLETP FRS. 29-30
(Author, 1977)

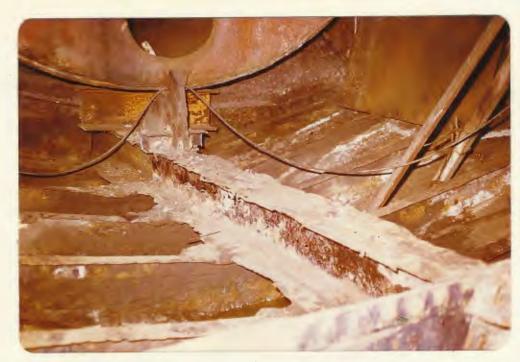
PLATE XX. EXTENSIVE CORROSION IN STOKEHOLD BILGE. MUCH OF THE STRUCTURE SHOWN INCLUDING KEELSON WAS TO BE REPLACED FRS. 28-32 (Author, 1977)

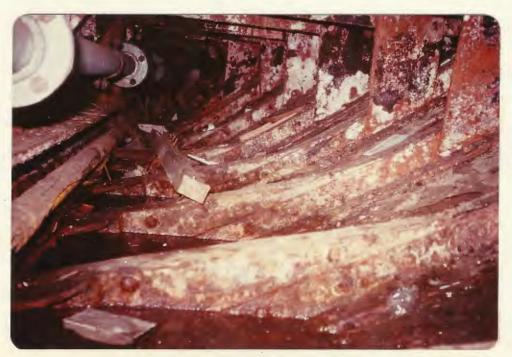
PLATE XXI. CORROSION IN FORWARD ACCOM.
BILGE. FRS. 41-52 (Author, 1977)

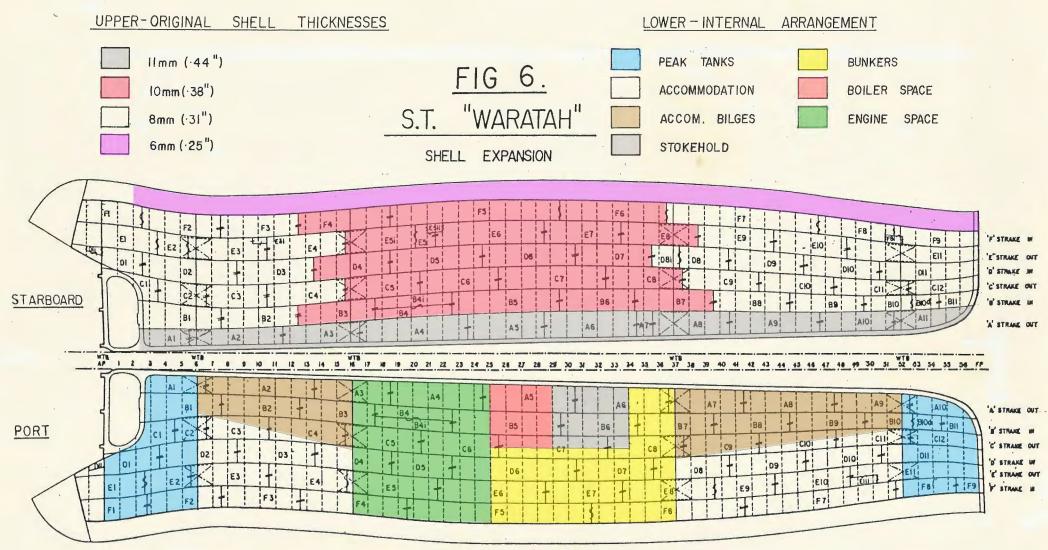
KEY PLATE AVERAGE < 67% OF ORIGINAL S.T. "WARATAH" PLATE AVERAGE 67-80% OF ORIGINAL READING < 67% OF ORIGINAL ULTRASONIC HOLE IN PLATE PLATE AVERAGE > 80% OF ORIGINAL THICKNESS SURVEY 1976 SHELL EXPANSION INSUFFICIENT INFORMATION READINGS IN MILLIMETRES STARBOARD WTB
AP | 2 3 4 5 6 7 8 9 | 0 | 1 | 12 | 13 | 14 | 15 | 6 | 17 | 18 | 19 | 20 | 21 | 22 | 23 | 24 | 25 | 26 | 27 | 28 | 29 | 30 | 31 | 32 | 33 | 34 | 35 | 36 | 37 | 38 | 39 | 40 | 41 | 42 | 43 | 44 | 45 | 46 | 47 | 48 | 49 | 50 | 51 | 52 | 53 | 54 | 55 | PORT DI FOR 11-1mm (11mm nom.) PLATE, 67% REMAINING = 7.4 mm " 9.5 mm (IOmm nom.) "

Conclusions drawn from the results of the ultrasonic tests were subject to a number of limitations. Although the results may have given a good indication of the average thickness of those plates tested, there was still a possibility of undetected local wastage and holing from pitting existing in what otherwise appeared to be acceptable plates. Although such defects would be undesirable, their localized nature would reduce the significance of their failure and would not greatly increase costs if discovered on the slipway.

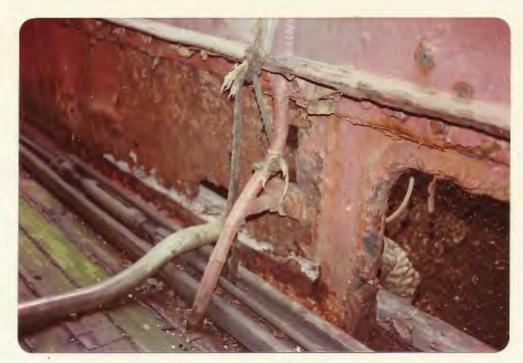
PLATE XXII. SHOWING CORRODED BULWARKS
AND A BUCKLED EXAMPLE OF
ONE OF THE FEW ORIGINAL
SPUR STAUNCHIONS WHICH
REMAINED (P. Johnson, 1976)

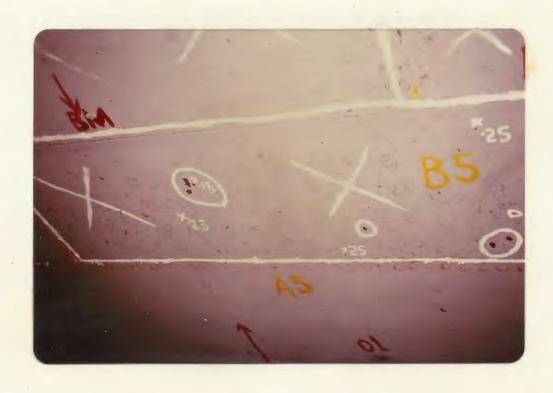
PLATE XXVII. (below)
DEFECTIVE PLATING R.B5P
WHITE CIRCLES INDICATE
RUST HOLES. SMALL
CROSSES, DRILL TESTS WITH
THICKNESS READING (inches)
MARKED ALONGSIDE.
(Author, 1977)

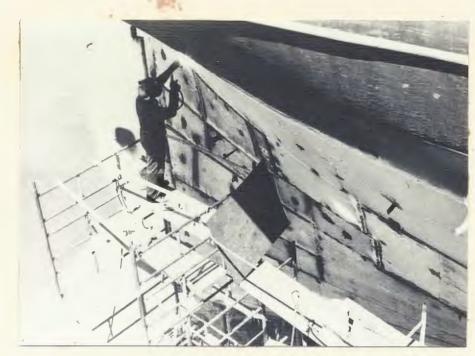
PLATE XXVIII. DOUBLING PLATES WERE
WELDED. OVER LARGE
SECTIONS OF THE BARQUE
"POLLY WOODSIDE'S" HULL.
THIS METHOD IS UNAUTHENTIC
AND DIFFICULT TO REVERSE (L. Doeg, 1974)

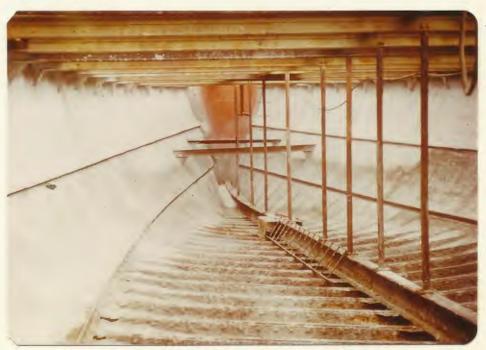
PLATE XXIX. REPAIRS SHOWING NO THOUGHT
FOR FUTURE MAINTENANCE.
REINFORCED CONCRETE LINING
IN BARQUE "JAMES CRAIG".
EXTERIOR OF HULL WAS ALSO
OVERPLATED (Author, 1979)

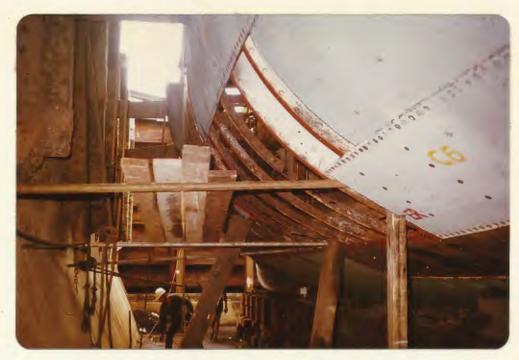
PLATE XXX. LARGE SECTIONS OF SHELL
PLATING REMOVED. PL. C6P WAS
PARTIALLY UNRIVETED TO ALLOW
REMOVAL OF PL. B6P (INSIDE STR.)
NOTE BILGE SHORES. (Author, 1978)

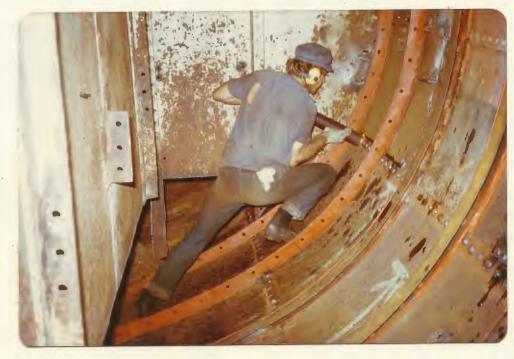
PLATE XXXIII. (below)
HOLDING UP RIVETS IN PORT
WING BUNKER. NOTE NEW
SECTIONS OF FRAMING. NEW
STRINGERS AND PORTIONS
OF REVERSE ANGLES HAD
NOT YET BEEN FITTED.
(Author, 1978)

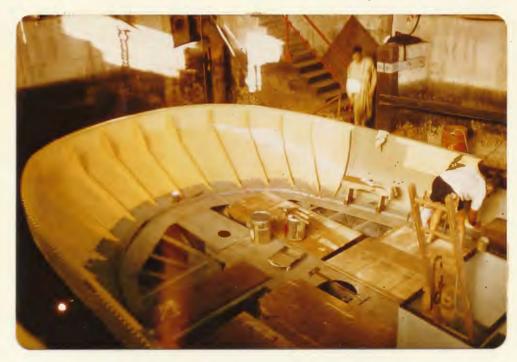
- i) The topgallant rail angle had a slight sag at its corners when viewed from aft. This was probably due to insufficient support during construction.
- ii) There was an area of local unfairness in way of cant frame 3 at the upper edge of the counter where the butt straps joining the topgallant bulwark to the counter plating underwent a transition from bevelled angles to knuckled plates.

PLATE XLII. NEW SECTION OF COUNTER
AND DECK STRINGER AS
COMPLETED. (Author, 1979)

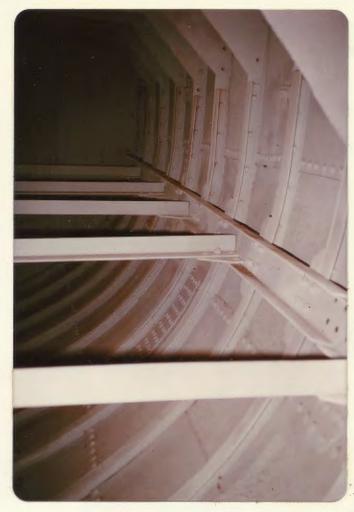
PLATE XLVI (left)
PORT WING BUNKER AFTER
HAVING BEEN REPAIRED
BLASTED AND PAINTED WITH
INORG. ZINC. COMPARE WITH
PLATES XVIII AND XXXIII
(Author, 1978)
