THE UNIVERSITY OF NEW SOUTH WALES SCHOOL OF MECHANICAL AND INDUSTRIAL ENGINEERING.

RESTORATION OF THE STEAM TUG 'WARATAH'.

BACHELOR OF ENGINEERING

(NAVAL ARCHITECTURE).

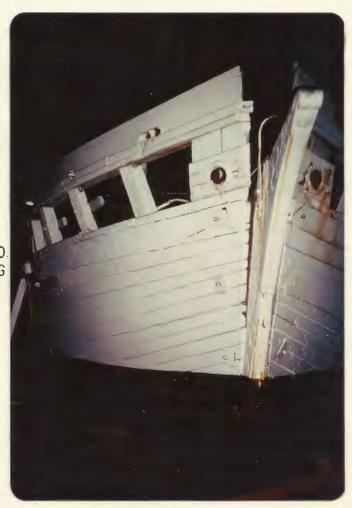
Dry preservation does not guarantee reduced rates of deterioration however. Some vessels, particularly wooden examples, have been known to deteriorate at an alarming rate once dry due mainly to insufficient thought given to stabilization. Such rapid deterioration occured with the timber ketch 'Annie Watt' after she was lifted from the water. See Plate XIII (Andrews, 1976, pp. 52-53.)

PLATE XIII. (right)
KETCH "ANNIE WATT" b.1870.
SHOWING HER BOWS OPENING
UP AFTER BEING PLACED
ON DRY LAND.(Author, 1977)

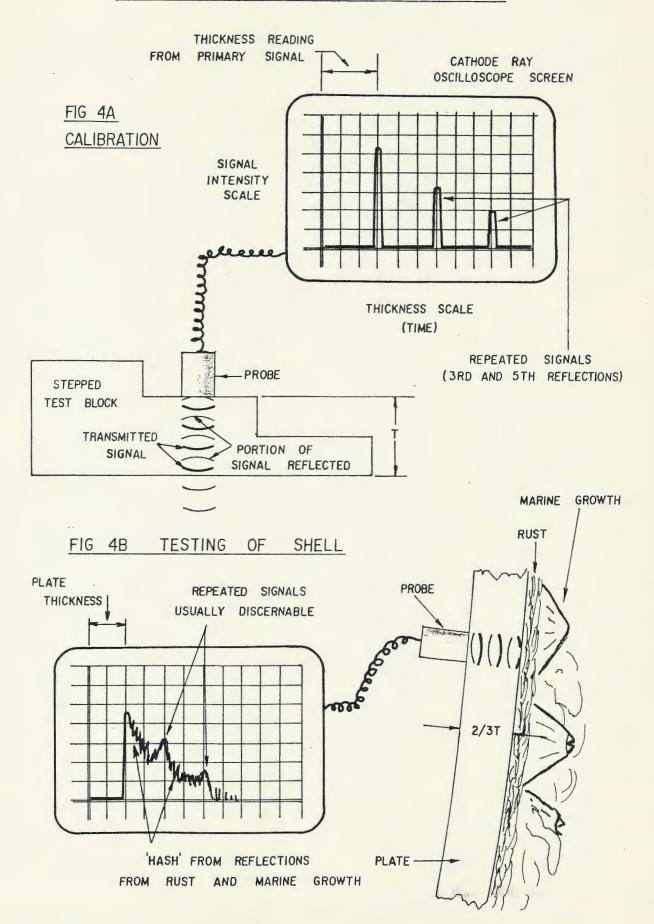
The readings obtained were plotted on a shell expansion (See Figure 5). The maximum allowable reduction of thickness was set, after consultation with the Lloyd's surveyors, at 33% of the original thickness as shown in Figure 6. Those readings which were less than 67% of the original thickness have been marked on the above plan as have the position of holes discovered during the ultrasonic testing. Those holes found below waterlevel were plugged with softwood bungs to stop the leaks.

KEY PLATE AVERAGE < 67% OF ORIGINAL S.T. "WARATAH" PLATE AVERAGE 67-80% OF ORIGINAL READING < 67% OF ORIGINAL ULTRASONIC HOLE IN PLATE PLATE AVERAGE > 80% OF ORIGINAL THICKNESS SURVEY 1976 SHELL EXPANSION INSUFFICIENT INFORMATION READINGS IN MILLIMETRES STARBOARD WTB
AP | 2 3 4 5 6 7 8 9 | 0 | 1 | 12 | 13 | 14 | 15 | 6 | 17 | 18 | 19 | 20 | 21 | 22 | 23 | 24 | 25 | 26 | 27 | 28 | 29 | 30 | 31 | 32 | 33 | 34 | 35 | 36 | 37 | 38 | 39 | 40 | 41 | 42 | 43 | 44 | 45 | 46 | 47 | 48 | 49 | 50 | 51 | 52 | 53 | 54 | 55 | PORT DI FOR 11-1mm (11mm nom.) PLATE, 67% REMAINING = 7.4 mm " 9.5 mm (IOmm nom.) "

Readings could not be obtained for all the plates due to inaccessibility and time limitations. 'A' and 'B' strakes, see Figure 3, were covered by the concrete in the bilges. A number of test holes were chizeled through the concrete in 'B' strake to obtain some representative readings of the plating beneath. The shell plating at the level of the cabin deck in the forward accommodation was inaccessible for testing because of portions of deck remaining. Because the equipment was on loan and time was limited, the after peak tank shell plating was not tested. It was felt that the exclusion of this area from testing would not be of great significance as the plates appeared in reasonably good condition and in any case defects would not have a major effect on the vessel as a whole.

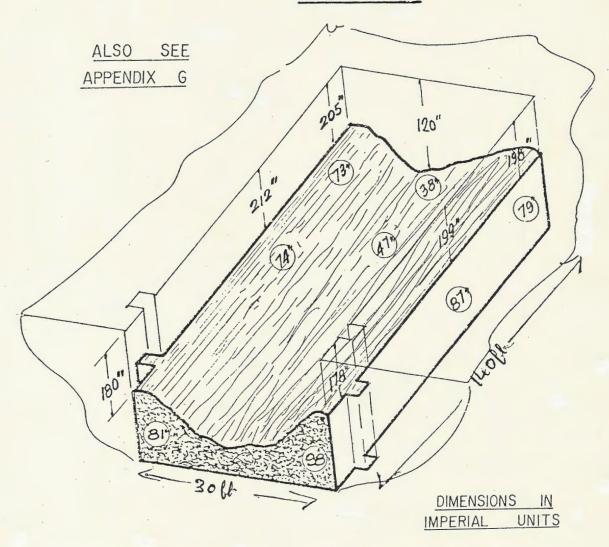
FIG II

SURVEY OF MUD
BLACKWATTLE BAY
DOCK 1977

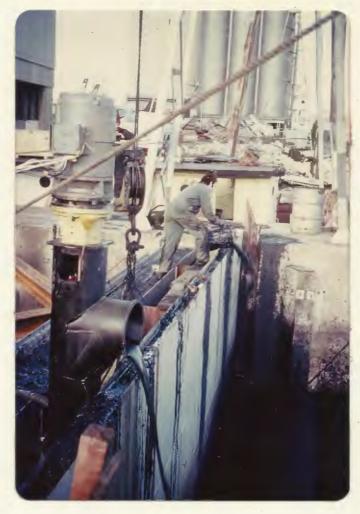
PLATE XXIV. (left)
SHOWING MUD BEING DUMPED
IN FRONT OF THE DOCK
GATE TO SEAL LEAKS.
DOCK PUMP IN FOREGROUND
(Author, 1977)

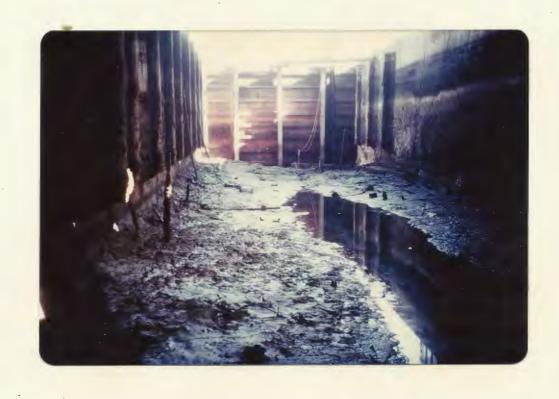
The pumping revealed over two metres of mud in the bottom of the dock (Plate XXV). After the previous proposals for dredging of the mud had been abandoned, it was felt that it was not worth considering other proposals until the situation could be ascertained with the dock pumped dry. A preliminary attempt was made to remove the mud by hand. Twenty volunteers worked a full weekend using shovels and buckets, but with little effect. The conditions were very difficult for this type of approach as the mud was so liquid that a man would sink up to his chest in it. It became obvious that such techniques would not be practical, at least in the earlier stages of the mud removal.

PLATE XXV. (below)
DOCK AFTER BEING PUMPED
DRY SHOWING THE MUD
2m DEEP COVERING THE
DOCK FLOOR (Author, 1977)

the mud as possible using a sludge pump. SYKES PUMPS generously lent the museum a submersible 3-phase, 15KW sludge pump to undertake this task. To enable the mud to be pumped, it was first made into a slurry by playing the stream of a fire hose onto it. Once it was a slurry, it was pumped into a hopper barge to be taken out to sea and dumped. Initially, the fire hose was manned from the top of the dock walls, but as the amount of heavy material exposed increased, it became necessary to man the fire hose from within the dock itself. To enable the slurry to be shepherded toward the pump from the extremities of the dock, pathways through the remaining debris had to be cleared. In time, the conditions on the dock floor had improved to the extent that work was begun removing this debris from the dock. A large variety of objects were found in the bottom of the dock including timber, scrap steel, bricks, tyres, rocks and a number of articles from the dock's original operation such as pipes and the lower block and hook from the hoist servicing the gates. Even the remains of a large tool kit were found buried in the mud. A large amount of timber was also found in the bottom of the dock. It would appear that this timber had floated in, become waterlogged and sunk.

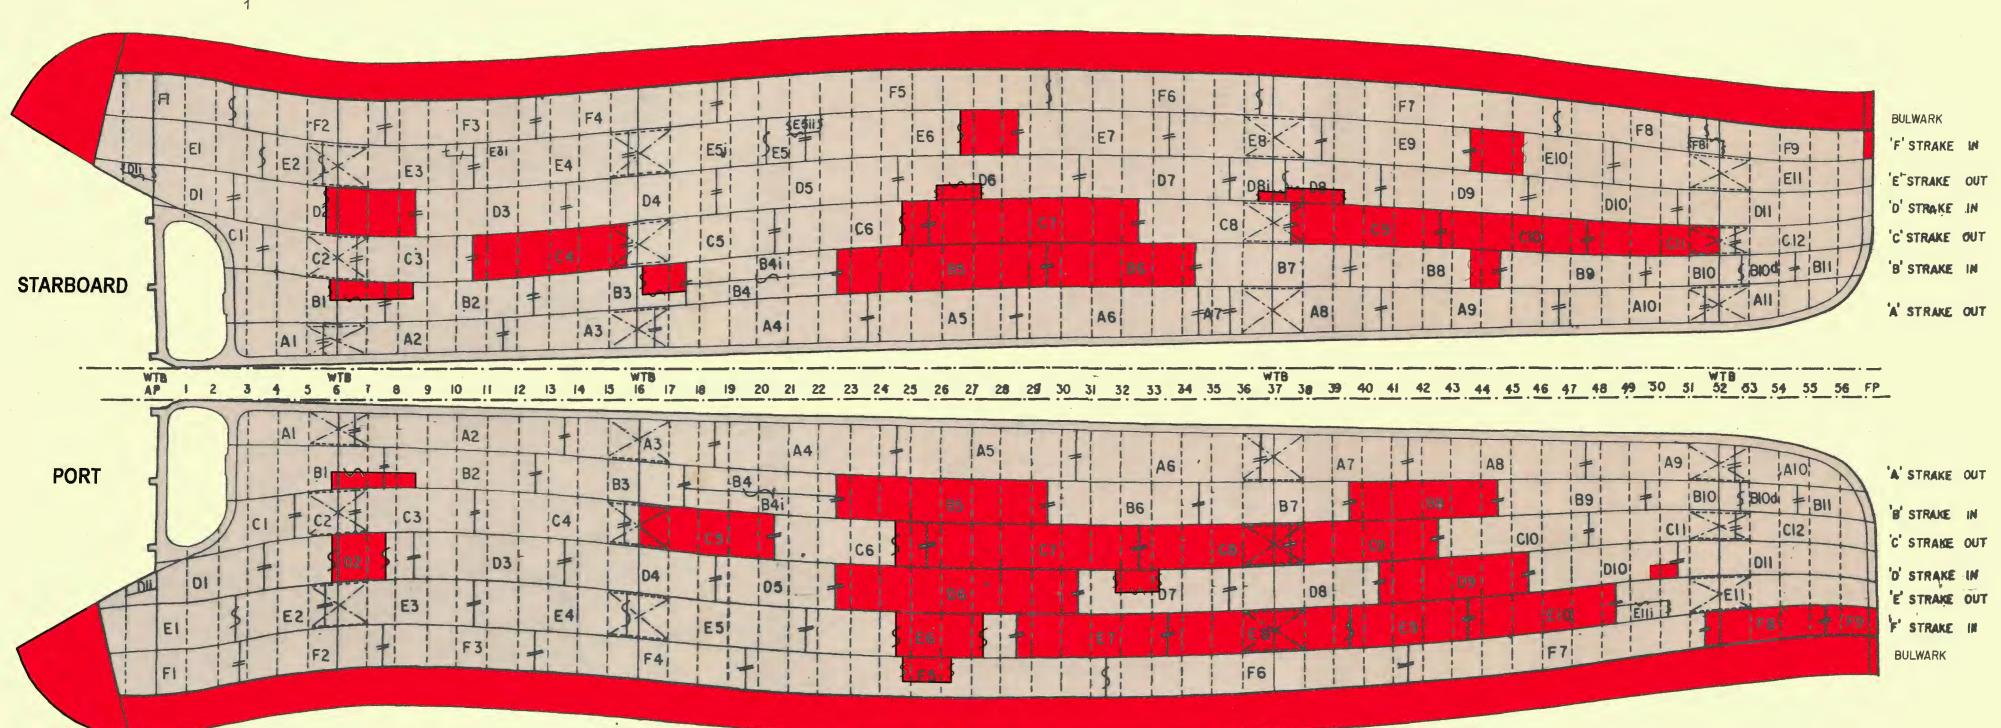
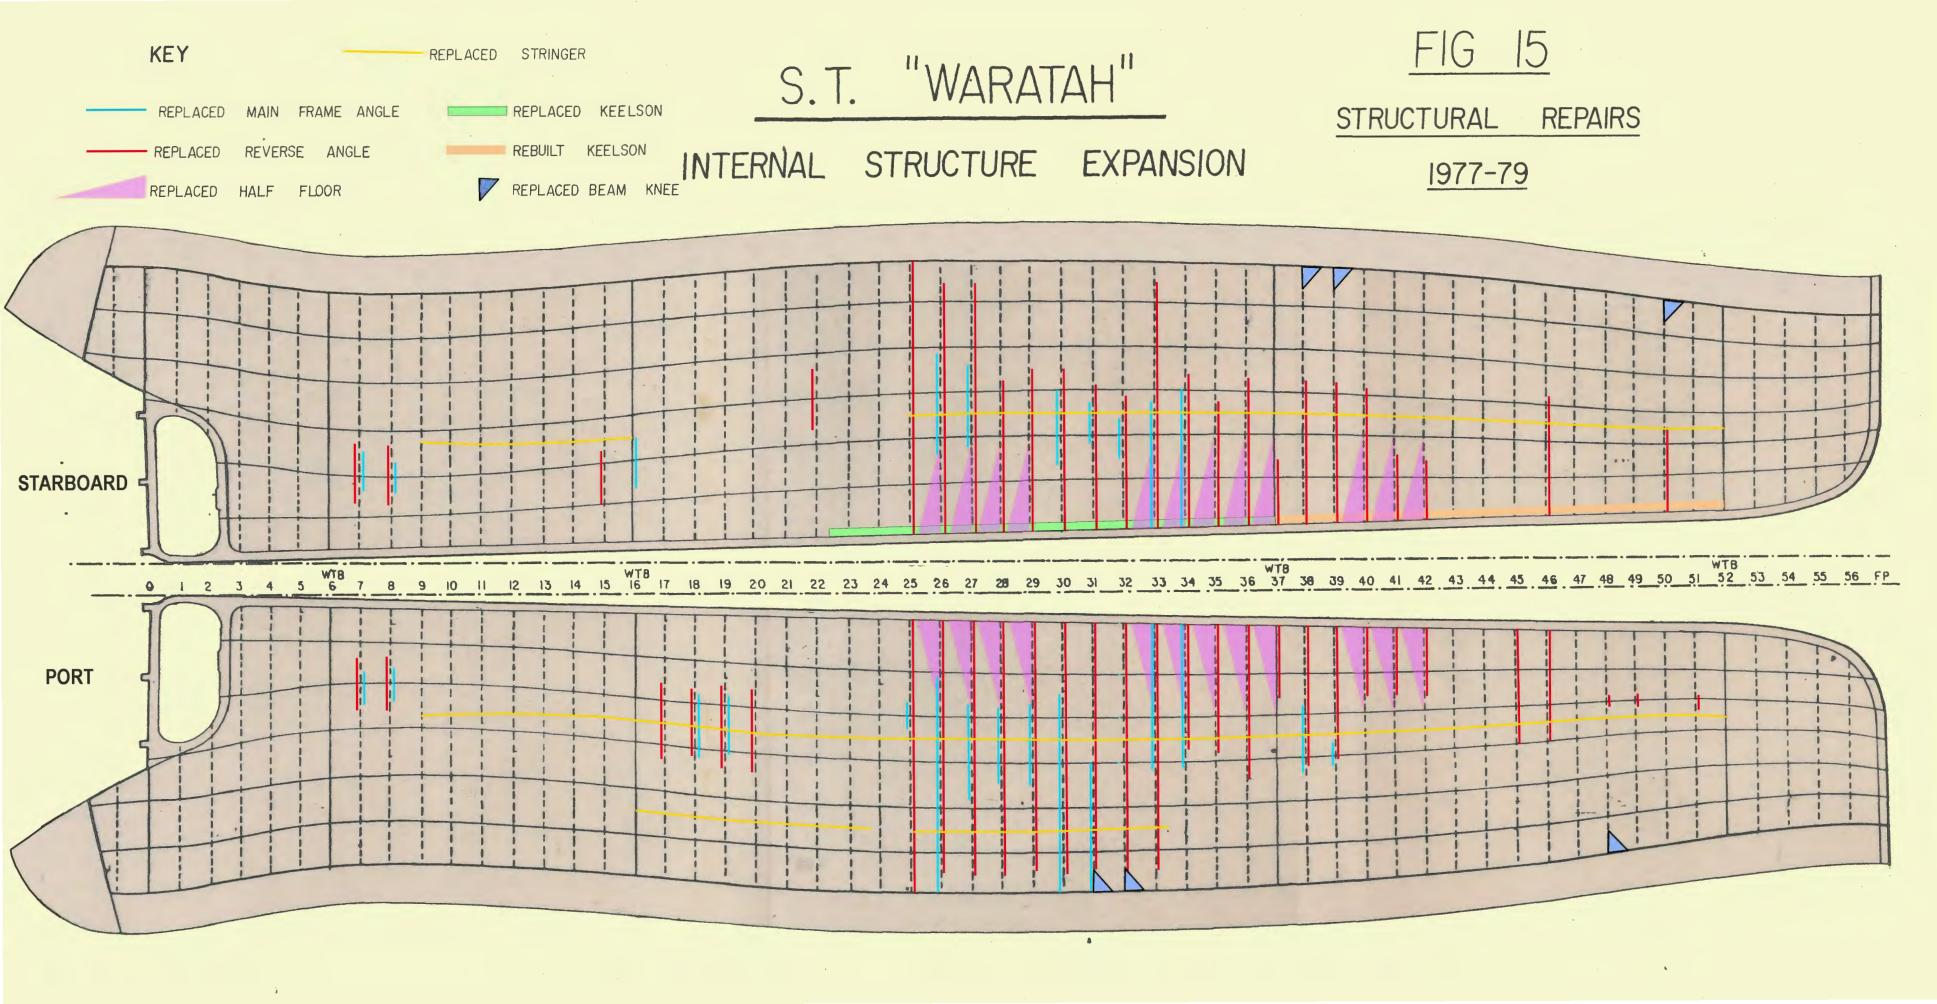
FIG 14

Once the 'Waratah' had been docked and the detailed inspections were well in hand; work was commenced on restoring the hull. Figures 14, 15, and 16 illustrate the extent of repairs to the shell plating, internal hull structure and deck structure respectively. This chapter is not intended to be a detailed record of all the work carried out during the restoration of the hull. Its purpose is to illustrate some of the more significant parts of the restoration; partly to give an indication of the scale of the work involved and how it was approached and partly to provide a number of practical examples for the concepts discussed in Chapters 3, 4 and 6.

The first major repairs undertaken on the hull were to the shell plating. Figure 14 shows the extent of the shell plating replacement. Approximately 20% of it was replaced. The following sections describe the replacement of these plates in some detail to show the basic skills used in most of the hull repairs.

because, even though they were unriveted, they were still held in position by the overlapping seams of the adjacent outside strakes. To enable these inside plates to be removed, portions of the adjacent outside strakes had to have their rivets removed so as to allow sufficient freedom of movement of the inside plates. Fortunately, many of the plates which were removed from inside strakes during the 'Waratah' hull restoration were adjacent to outside strakes which, themselves, had to be replaced. (See Figure 14).

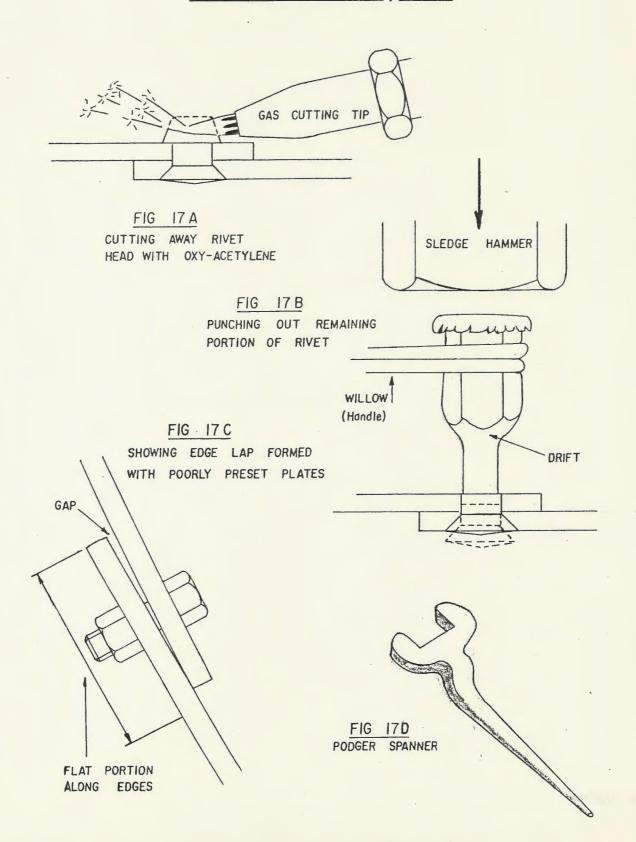
FIG 17 REMOVING RIVETS, ETC

The remaining portion of the rivets was removed by two men, one holding a drift on a long willow over the rivet, the other wielding a 4.5 - 6.0 kg sledge hammer. (Figure 17b). Each rivet required a number of heavy blows from the sledge hammer before it was removed. In some of the more confined areas, specially shaped drifts had to be used and at times the rivets had to be removed by one man alone.

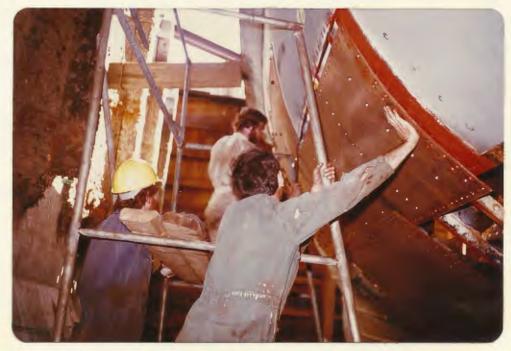
PLATE XXXI. FITTING R. D8P (INSIDE STAKE)
BENEATH THE LAPS OF
ADJACENT OUTSIDE STRAKES
(Author, 1978)

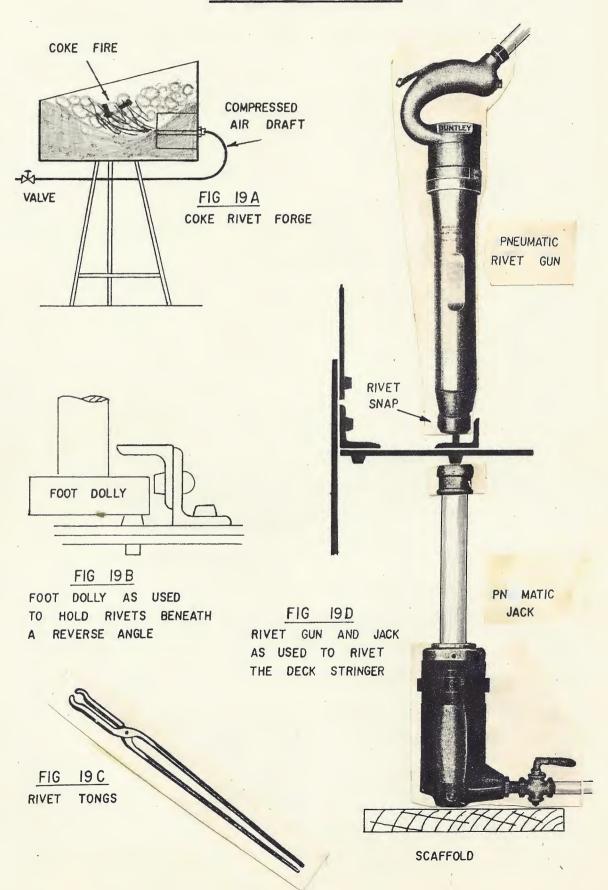
FIG 19 RIVETING TOOLS

The rivets were heated to a yellow heat (about 1100° c) at which stage they exhibited a glazed, shiny appearance. The rivet, once hot, was then removed from the forge with tongs (See Figure 19c) and passed to be placed into a rivet hole.

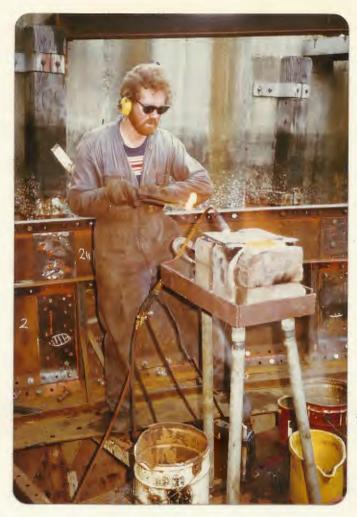
PLATE XXXII. (left)
HEATING RIVETS USING THE
OXY-PROPANE FORGE. NOTE HOT
RIVET IN TONGS. (Author, 1978)

PLATE XXXIII. (below)
HOLDING UP RIVETS IN PORT
WING BUNKER. NOTE NEW
SECTIONS OF FRAMING. NEW
STRINGERS AND PORTIONS
OF REVERSE ANGLES HAD
NOT YET BEEN FITTED.
(Author, 1978)

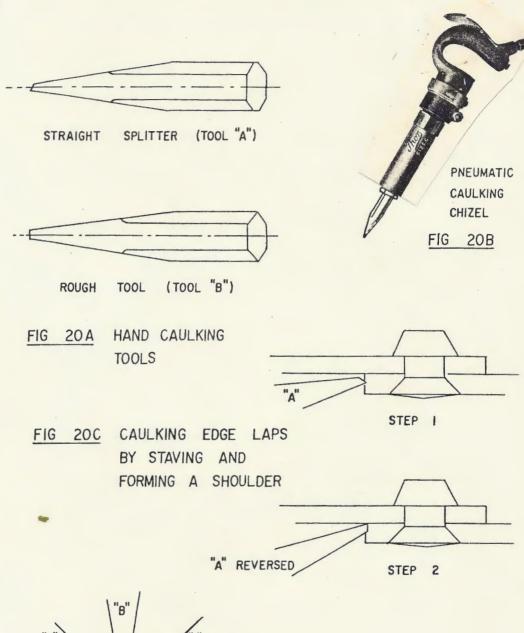
FIG 20 CAULKING, TOOLS AND PROCEDURES

Once the riveting on the shell plates had been completed, they were caulked. Caulking of the plates was achieved by burring one plate edge onto another to form a watertight seal using either hand or pneumatic caulking tools (See Figure 20). The caulking of edge laps (the plate seams on the shell) employed a different method to that used when caulking the butt joints. The edges of lapped joints were thickened by staving with a chizel point, so forming a shoulder to caulk the joint. (See Figure 20c).

FIG 20D CAULKING BUTT JOINTS
BY ELONGATING
AND THINNING

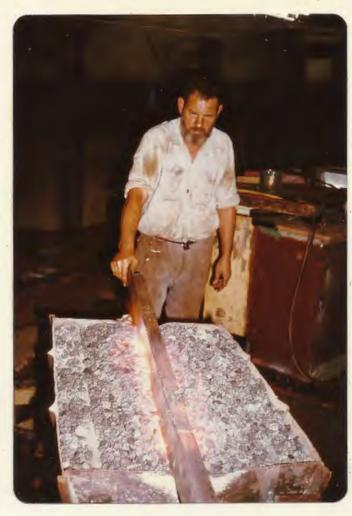
PLATE XXXIV. (left)
HEATING FRAME ANGLE IN
COKE FORGE. (Author, 1978)

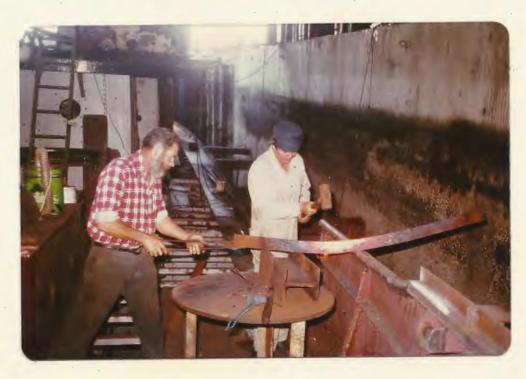
PLATE XXXV. (below)
HOT WORKING ANGLE FRAMES
TO SET CURVATURE.(Author,
1978)

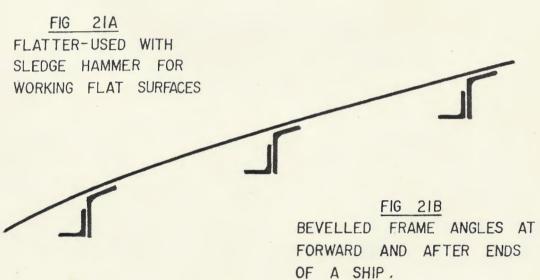
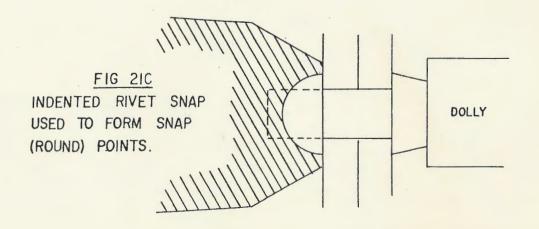
FIG 21 FRAME REPAIR DETAILS

The main angles of transversely framed, riveted ships were progressively bevelled in the forward and aft extremities of the ship so that they would come into close contact with the shell plating and yet have their webs perpendicular to the centreline of the ship (See Figure 21b). Fortunately, nearly all of the main angles replaced during the 'Waratah' restoration were in the midships region and therefore did not require bevelling. The only exceptions were the small sections in frames 7 and 8 which were bevelled in situ.

All the rivets in the transverse framing, other than those passing through the shell plating, were finished with a 'snap' (or rounded) point. (See Figure 21c). This point was formed by using a special indented snap in the rivet gun.

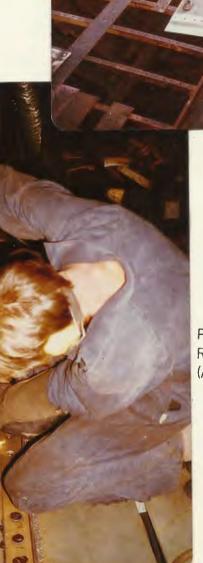
PLATE XXXVI. (right)
NEW STRINGER PLATES CUT
AND DRILLED PRIOR TO
BEING BOLTED IN POSITION
(Author, 1978)

PLATE XXXVII. (left)
RIVETING DECK STRINGER
(Author, 1978)

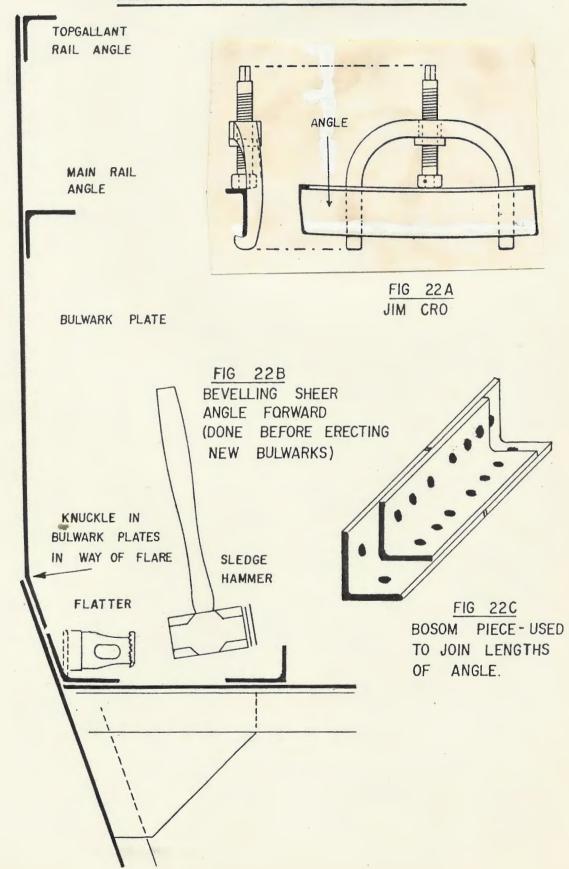
FIG 22 DECK STRINGER REPAIR DETAILS

Amidships, the angles did not require presetting to follow the deck edge. Wedges and clamps were used to force the angles into position ready to be drilled where they lay. As the curvature became more pronounced towards the extremities of the vessel, the sheer and waterway angles had to be preset before fitting. To obtain the moderate curvature required at the quarters of the 'Waratah', the angles were worked cold by striking them with a sledge hammer over the bending jig. At the extreme bow and stern, more powerful techniques had to be used. The extreme curvature was set using a device called a 'jim-cro' which is used extensively to bend railway tracks. (See Figure 22a).

(See Figure 22b). Bevelling was done once the sheer angle had been securely bolted to the stringer plate. About 30 cm of the vertical flange and root of the angle was heated at a time with the oxy-propane heating torch. Once this had attained a bright red heat, it was worked to the correct bevel by striking the vertical flange with a sledge hammer and flatter until it lay snugly against the sheer strake. The same operation was then carried out to adjoining sections progressively bevelling the angle along its whole length.

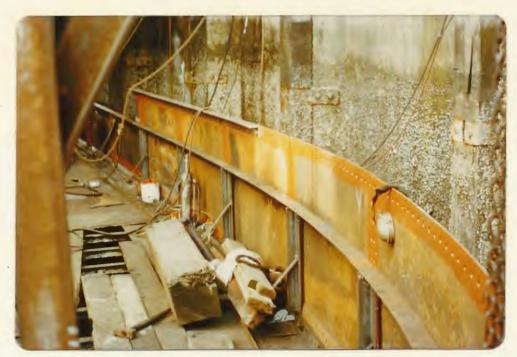
PLATE XXXVIII. NEW SECTION OF BULWARK
UNDER CONSTRUCTION SHOWING
MAIN AND TOPGALLANT RAIL
ANGLES AND TEMPORARY
STAUCHIONS (P. Jones, 1978)

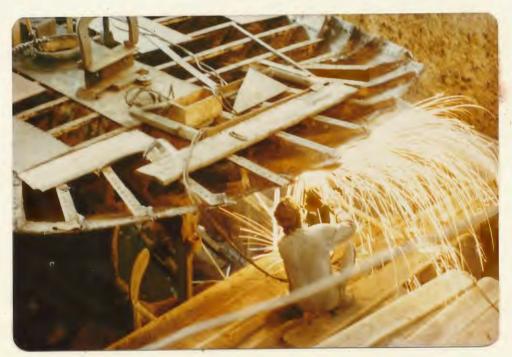
PLATE XXXIX. UPPER PORTION OF COUNTER CUT AWAY SHOWING CANT BEAMS AND STUBS OF CANT FRAMES. (P. Jones, 1978)

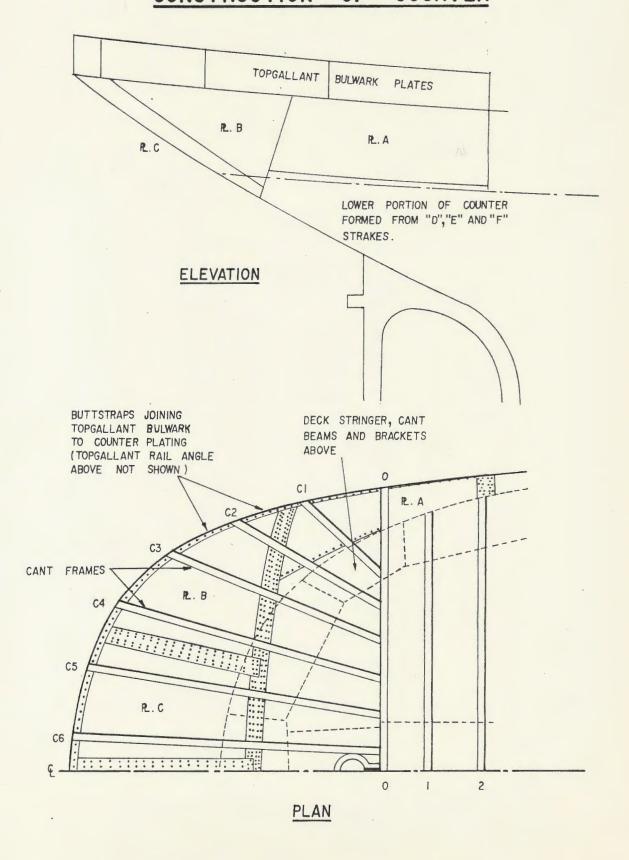
FIG 23

Not only had the shape of the upper portion of the counter been altered in past, but also its construction. Fortunately, sufficient detail remained of the original riveted structure in the otherwise welded structure, from which to determine the probable authentic construction as shown in Figure 23.

CONSTRUCTION OF COUNTER

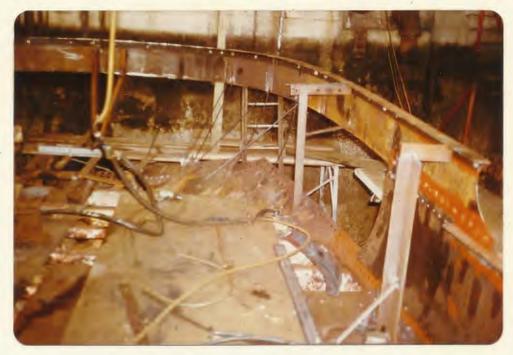
PLATE XL. TOPGALLANT RAIL ANGLES

AND BULWARK PLATES FITTED.

STAYS AND FAIRING TRACES

ARE ALSO FITTED (PJones, 1978)

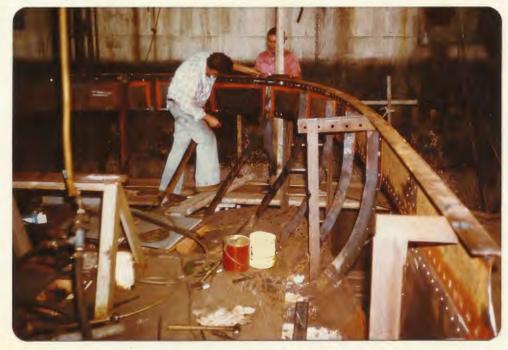
PLATE XLI. FITTING. NEW CANT FRAMES
AROUND. THE STERN.(Author, 1978)

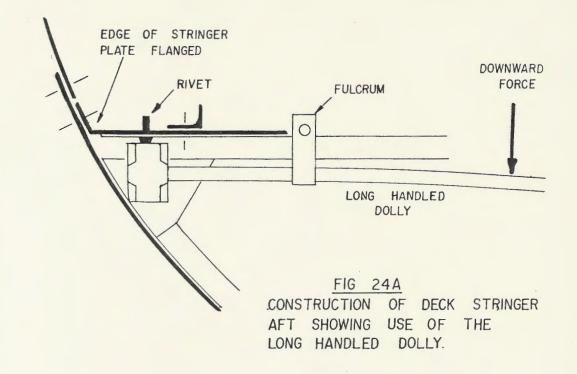
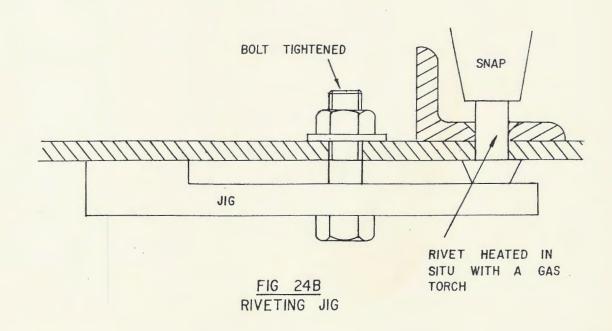
FIG 24 RIVETING AFT DECK STRINGER

The original form of the deck stringer was as shown in Figure 24A. Portions of this deck stringer had been replaced in the past by welding a new stringer plate along its intersection with the sheer strake. The complete length of the deck stringer around the stern was removed to allow the repairs to the upper portion of the counter. Once these repairs had been completed, work commenced on fitting a new deck stringer around the stern.

- i) Where the clear space was sufficient, a dolly at the end of a long handle which acted around a fulcrum was used. (See Figure 24A). This method dated back to the era before the use of pneumatic tools in shipyards and was extensively used for work such as the riveting of hollow iron spars. In many ways, this method was found to compare favourably to the use of the pneumatic jack even in more open areas.
- ii) There were a number of cases where the method of holding up described in i) above could not be used, particularly in way of the cant framing and close alongside flared sheer plates. In these cases, the method shown in Figure 24B was used. A cold rivet was placed into the rivet hole and the jig bolted in position
